**OPTIMUM MIX OF ARMORED VEHICLES FOR USE**

**IN STABILITY OPERATIONS**

**ACTIV Project No. ACG 69F**

**VOLUME TWO OF THREE VOLUMES**

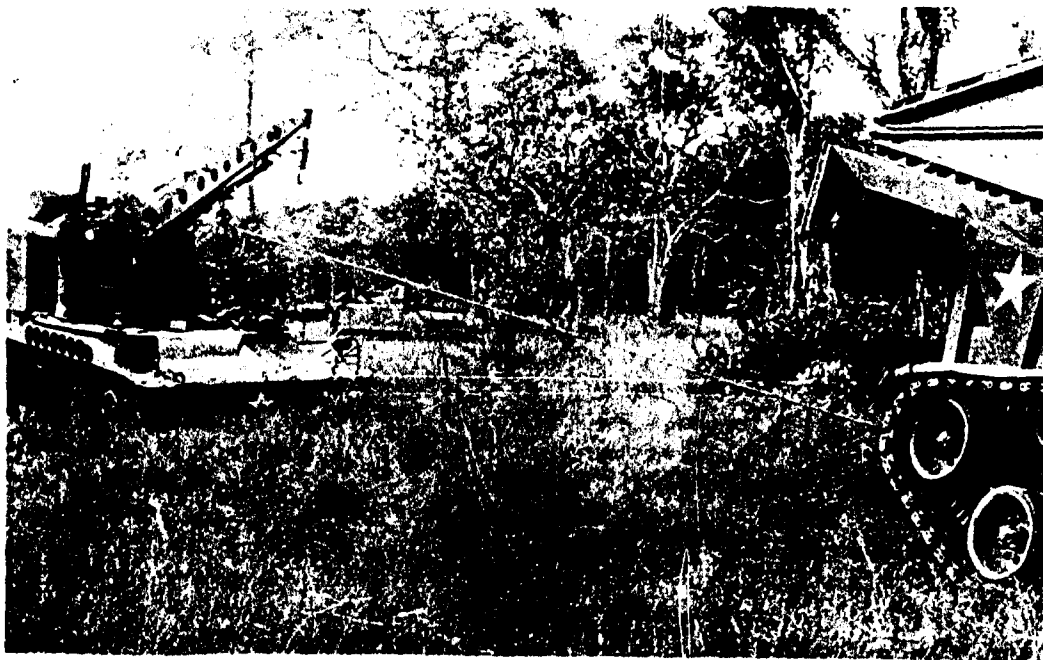
FIGURE G-13 (U). Recovery of Mired AVLB.

The AVLB section operated under squadron control and supported cavalry troops and the tank company on a mission basis. The size of the launcher and bridge presented problems when operating in jungle areas not cleared by preceding vehicles. The increased clearances required for turns became critical when traveling through rubber plantations. When supporting cavalry troops during the wet season, the AVLB occasionally became mired down or caused roadways to cave-in due to its great weight. As a result, commanders expressed an interest in the development of a lighter bridge with better trafficability and the capability of supporting all vehicles in a cavalry troop. All commanders thought the AVLB was a valuable asset, and wished to retain this section as currently organized. The squadrons used one or more bridges on an average of 28 percent of the days in the evaluation period.

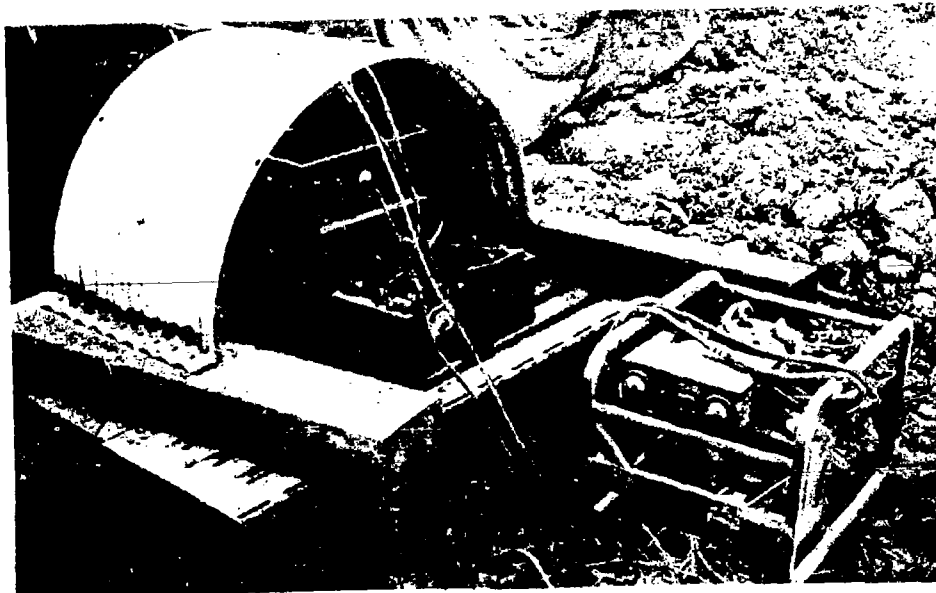
FIGURE G-22 (U). Rectifier Providing Charge to DC Batteries.

Commanders and communication officers indicated a need for three rectifiers per squadron to convert available 110-volt AC power to 24-volt DC power for operating stationary communications equipment in the FSA and regimental rear base camp. Many of these items were on hand. Use of this equipment precluded the wasteful running of tactical vehicle engines to generate electricity. This requirement was a derivative of the semifixed bases which units were required to maintain in RVN.

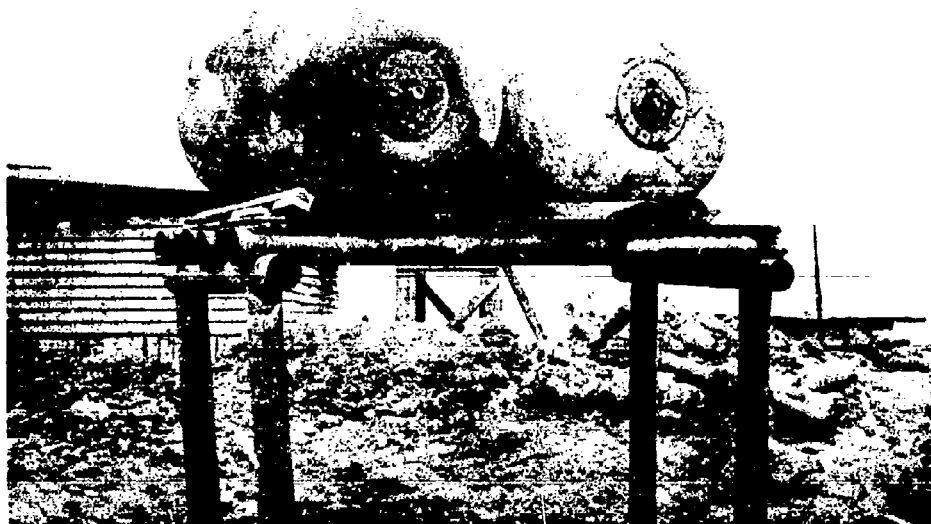
Because of the nature of operations and the limited amount of POL handling equipment, the resupply of Class III was a problem. In one battalion, a single M49C 1200-gallon fuel truck made continuous trips along the road the unit was securing, refueling each vehicle every other day. This was not felt to be a satisfactory arrangement. The unit had requested an additional M49C to be issued on temporary loan. The other two battalions relied primarily on the tanks returning to the FSBs, where bulk fuel was available. If the mission required, an M548 with a Class III container would accompany, or be sent to, the maneuver elements. Air resupply resulted in problems in dispensing fuel from containers as discussed in paragraph 2d(3), Annex G.

FIGURE J-12 (U). FSB Refueling Point.

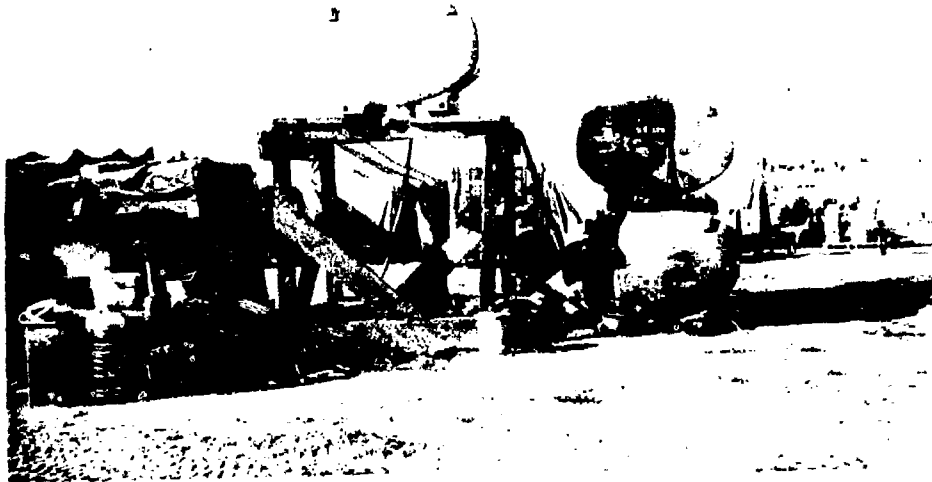
FIGURE J-14 (U). Use of 600-Gallon Tanks for Water Storage at FSB Mess.

All personnel interviewed felt the authorized water handling equipment, five 400-gallon water trailers and five 250-gallon collapsible drums, was inadequate. The collapsible drums were considered to be cumbersome and impractical. As a result they were not used. Each battalion had on hand several excess water trailers. One battalion had an M50C, 1200-gallon water truck issued on temporary loan. Another battalion employed two of its authorized tank-and-pump units for water, one mounted on an M54 and one on an M548. Each battalion used 600-gallon tanks for water storage at FSBs and base camps.

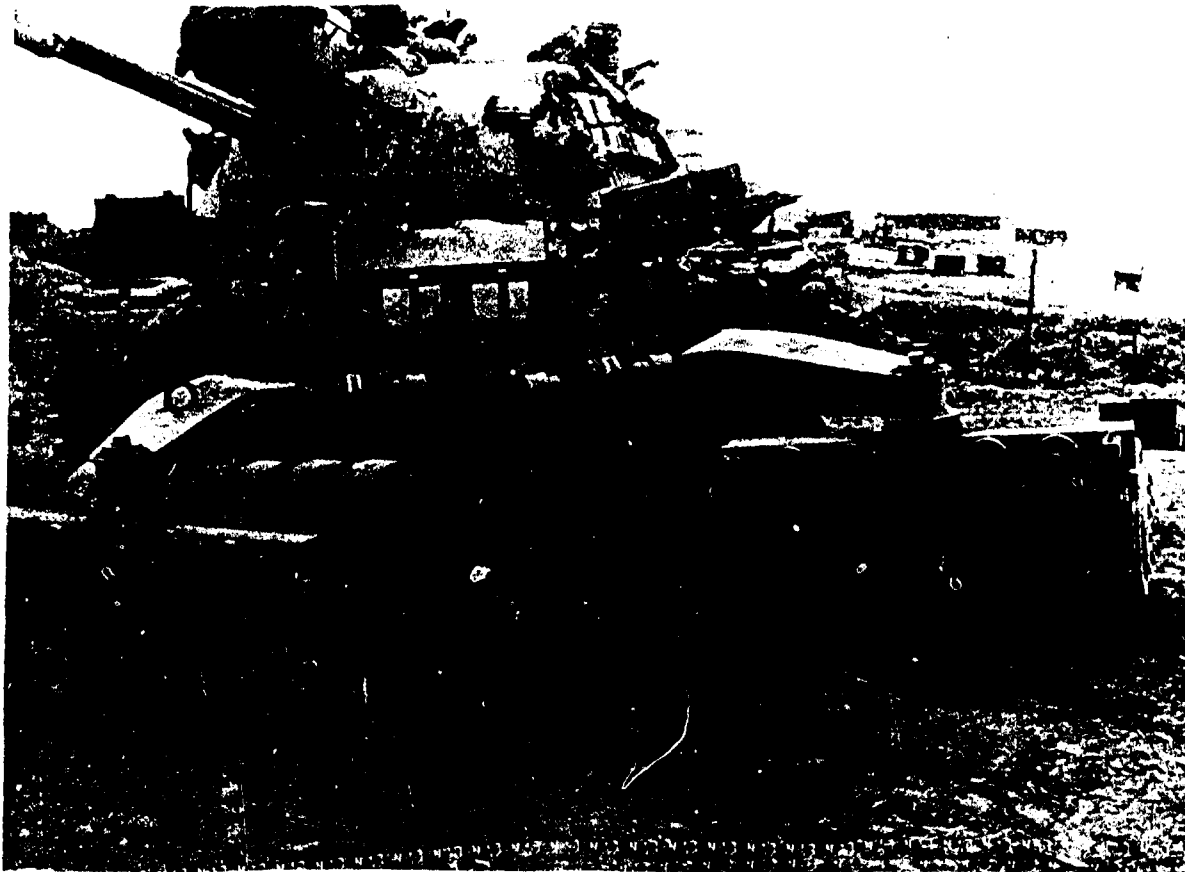
FIGURE J-15 (U). Tank-Mounted Mine Roller, ENSURE 202.

(a) The tank battalion commanders who had experience with the vehicle-mounted mine rollers in RVN were unimpressed. Their statements concerning the adequacy of available equipment and future requirements paralleled those made by commanders in the ACR.

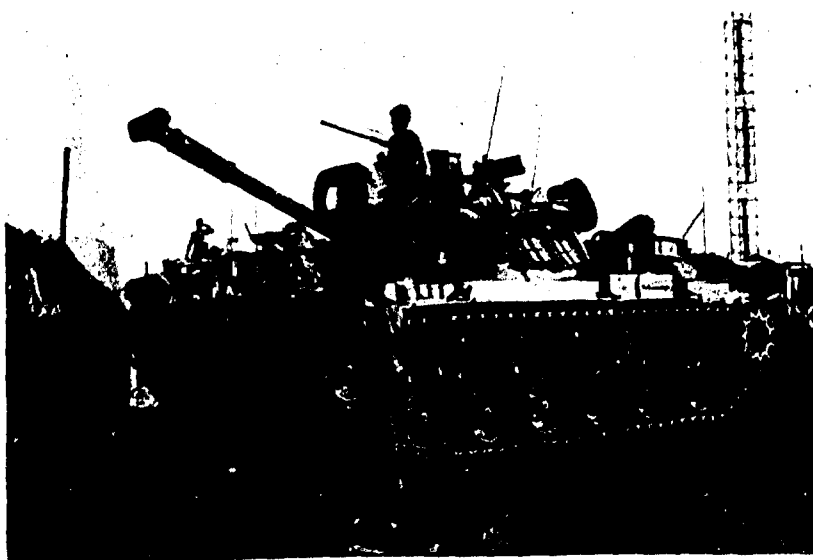
the interrelationships between equipment and techniques resulted in locally adapted field modifications which have quantitative as well as qualitative impact. The various systems must be considered as an integrated capability, parts of which may require modifications to optimize the whole functional area.

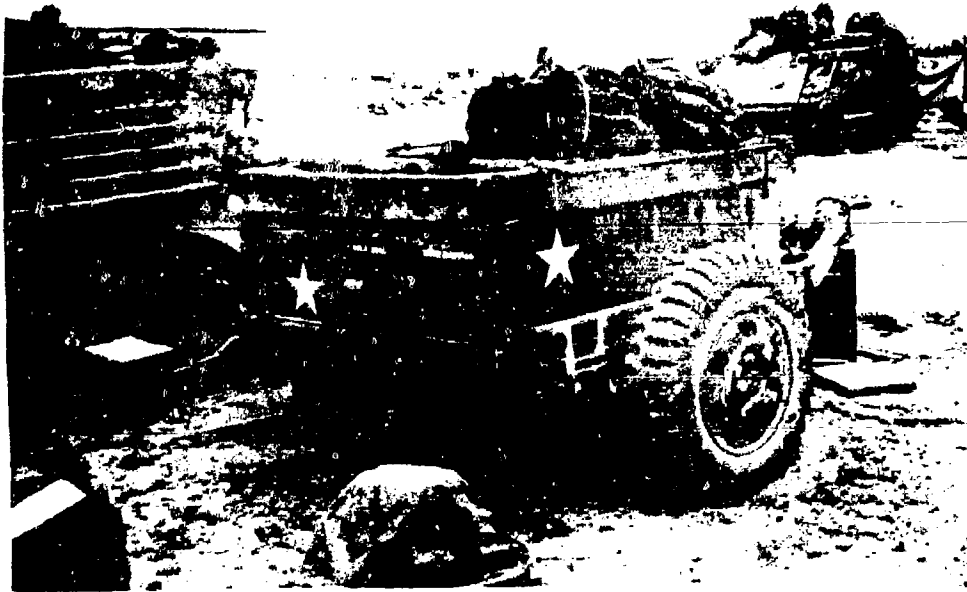
FIGURE K-17 (U). Heavy Mortar Platoon Ammunition Trailer.

f. Provision for on-vehicle stowage of ammunition was considered inadequate. As a result nearly all M106A1 mortar carriers were overloaded, carrying an average of 113 4.2-inch rounds in addition to 9000 rounds of machinegun ammunition. Overloading contributed to breakage of torsion bars and at times created trafficability problems due to increased ground pressure. Two battalions attached an M548 from the battalion support platoon to the mortar platoon to carry additional ammunition. Two other units obtained ammunition trailers, which were towed by an M106A1 or the FDC M577A1. This was considered impractical, since it delayed fire missions called for during movement.

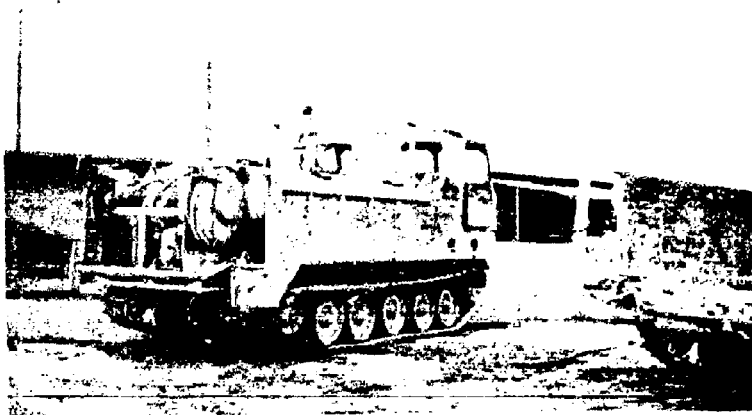
FIGURE K-23 (U). Tank and Pump Unit Mounted on M548 Tracked Cargo Carrier.

The nature of operations and the limited amount of authorized POL handling equipment caused the resupply of Class III to be a continuous problem. Three battalions resupplied POL to forward elements by air using collapsible 500-gallon drums. Problems encountered are discussed in paragraph 2d(3), Annex G. One battalion had the companies return to the logistical base on a daily basis for refueling. The remaining battalions mounted tank and pump units or collapsible drums on M548's (Figure K-23) and, as required, they sent these vehicles to the companies. In some cases, the M548's accompanied elements in the field. POL handling equipment is discussed in paragraph 31(4), below.

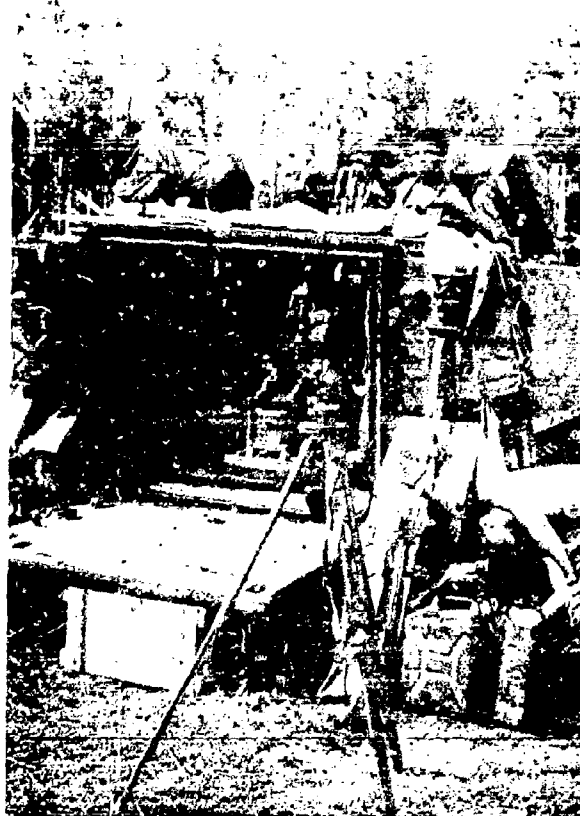
FIGURE K-27 (U). M125A1 Mortar Carrier Employed on NDP Perimeter.

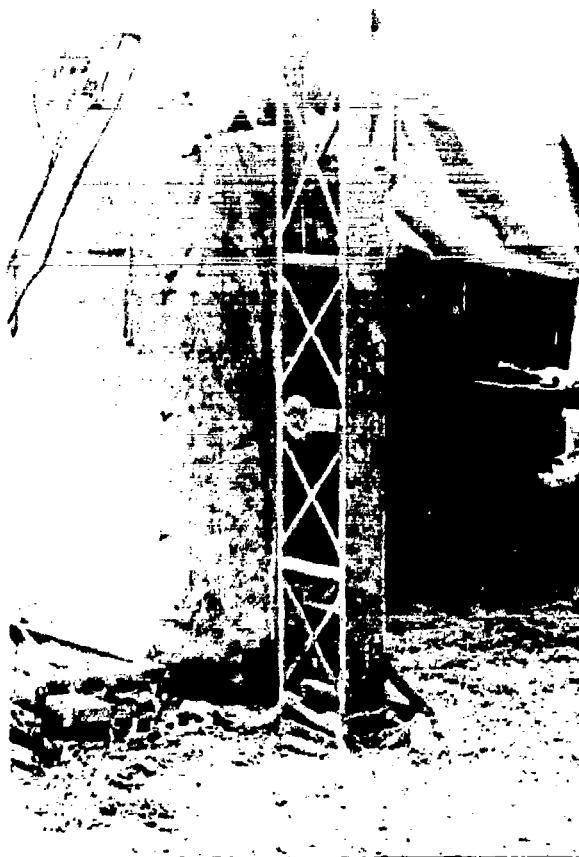
FIGURE K-35 (U). AB-577 Antenna Base.

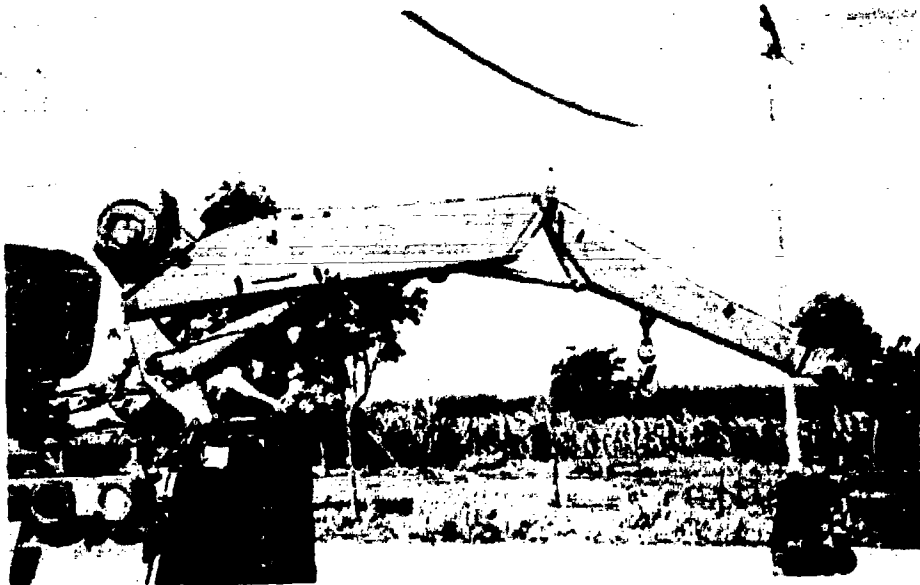
FIGURE L-7 (U). Fitters' Vehicle Crane.
